# Safety Inspection Report

Annual Inspection

## Churt Recreation Ground

17 June 2024

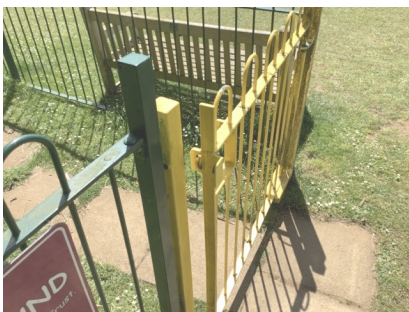
The gate's closing mechanism does not work correctly.

Doesn't self-close fully. Adjust closing mechanism.

Adjust to allow gate to self close. Ideally gate from open should not close in less than 5 seconds.

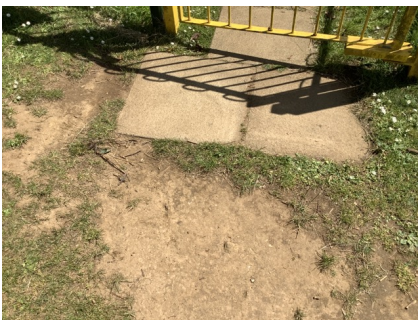
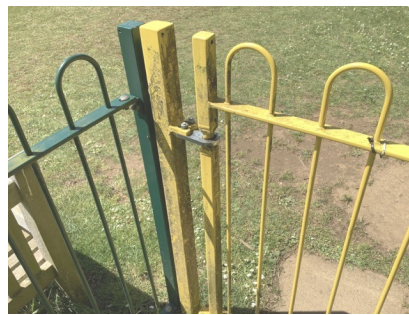
Minor repairs are needed.

Trip point around entrance. Repair.  
Squeaking when in use. Lubricate.

Make level., Repair.

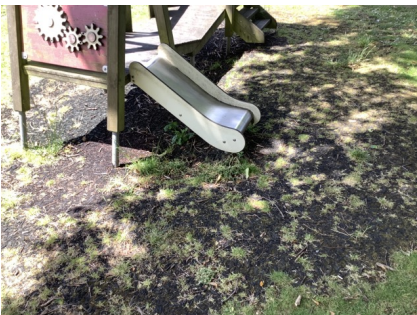
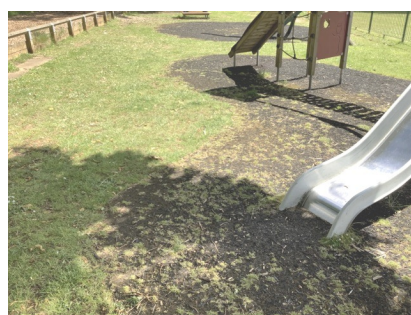
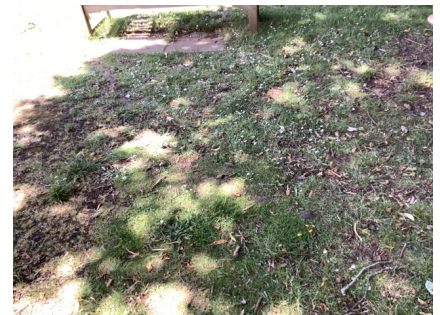
Surface is uneven.

Bonded rubber surface is uneven in places. Monitor and repair as needed. Tree roots exposed throughout.

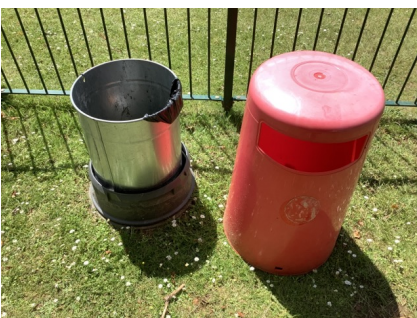
The item is unlocked.

Liner can be easily removed.

Lock.

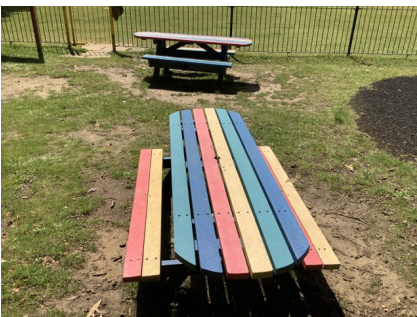
Portable equipment must remain outside the minimum space of the permanently installed items. Free movement of children within the play area may be affected. Without effective control the risks will increase.

The inspector recommends that the assets are secured in a suitable location.

Monitor and control the placement of portable items.

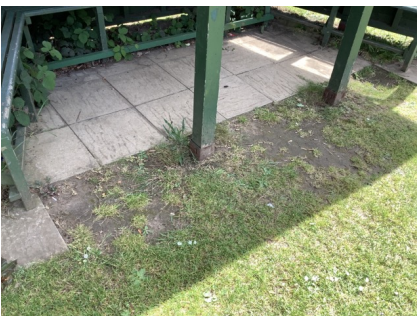
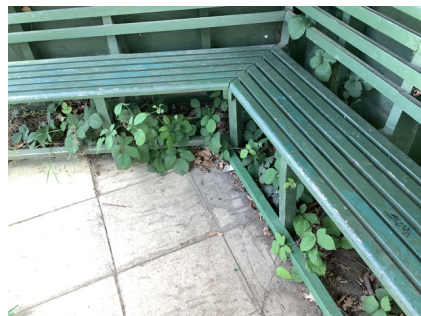
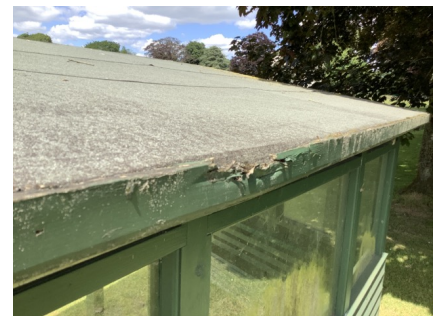
Moderate repairs are needed.

Decay to roof section. Replace affected parts.  
Trip points throughout. Repair.  
Remove all weeds underneath seats.

Repair., Read the notes for further action.

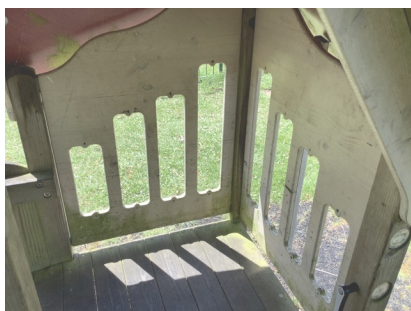
Item has some parts missing.

Missing chimes expose potential entrapments in barriers.

Replace the missing parts.

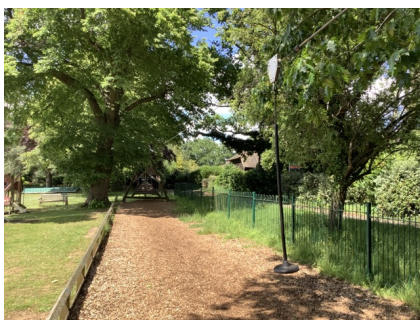
Cable is loose.

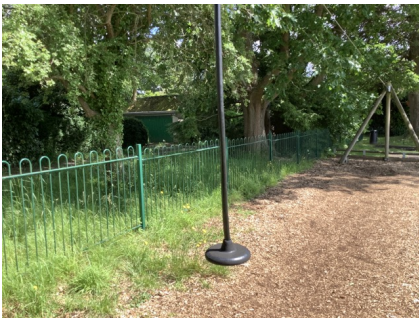
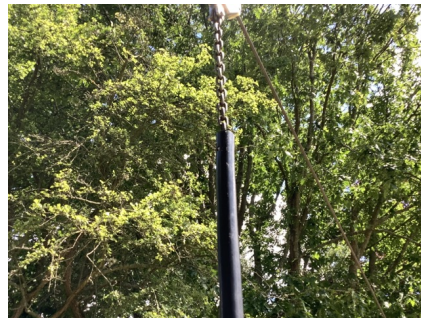
Top of cover loose. Install a through bolt approximately 100 mm from top.

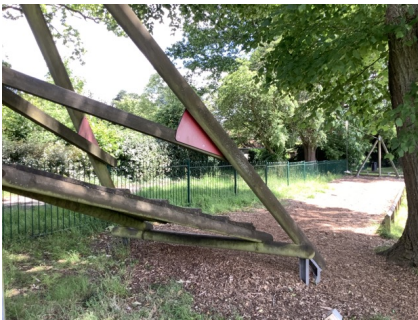
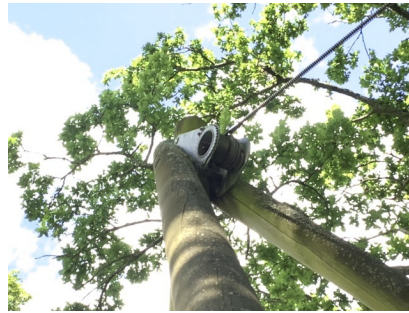
Cables have been known to fail under load due to wear and corrosion. This is generally where the cable enters into a tube, top bar, sleeve or similar, where the wire is in contact and wears and frays over time, but can happen anywhere on the cable. It is important to inspect any hidden parts at least annually. Damaged cables require replacement. This cannot be determined during an annual inspection, and is excluded from our inspection. This can lead to a high risk if no action is taken. Refer to the manufacturer's instructions to ensure the correct check is carried out.

Conduct an appropriate dismantling inspection according to the manufacturer's instructions, and at least annually. The trolley mechanism can be checked at the same time.

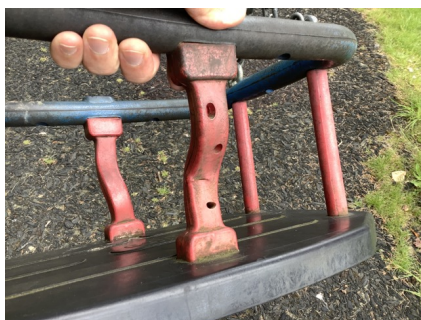
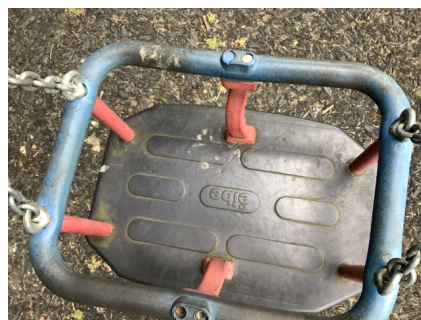
The central strap is loose / missing / damaged.

Damaged due to frame being stood on.

Repair/replace strap.

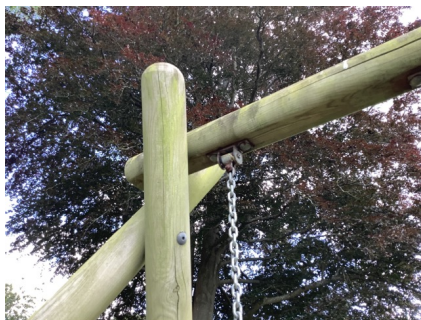
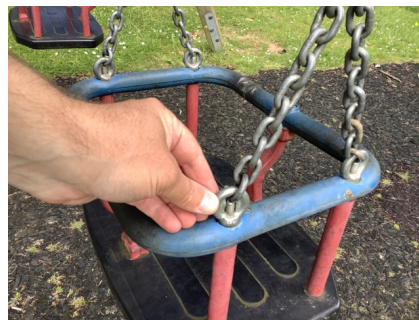
Bolt(s) loose.

Top bar loose to support legs.  
Eye bolts loose on seats.

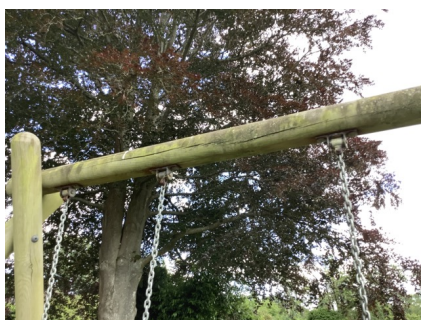
Monitor for further deterioration and signs of decay within.  
Monitor timber top bar for shakes near to the fittings as this could potentially cause sudden failure of the unit.

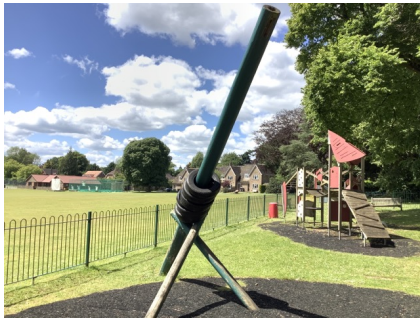
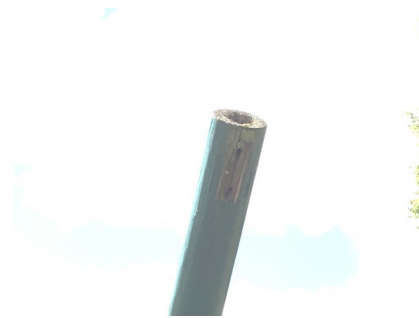
There is decay to timber components which may affect structural integrity. We do not recommend replacing rotten supports with timber posts which are directly set in the ground due to the increased problem of timber rot, especially in posts in contact with the ground.

Previous Percussion testing was inconclusive in areas. The timber at the top of the asset appears to be in a poor condition. Some evidence of softening within the shakes. The rate of decay appears to be quite slow. However, near fixing points. Replace.

Read the notes for further action., Replace decayed components where possible and plan replacement of item. Check on a routine basis, especially at ground or foundation level., We recommend resistance penetration testing to determine the internal condition of the timber. We can undertake this testing at additional cost. Please contact us for details.

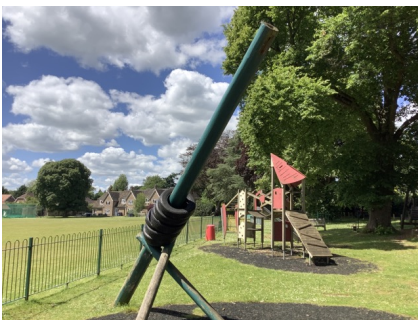
Swing seat(s) missing.

Replace.

Replace when available.

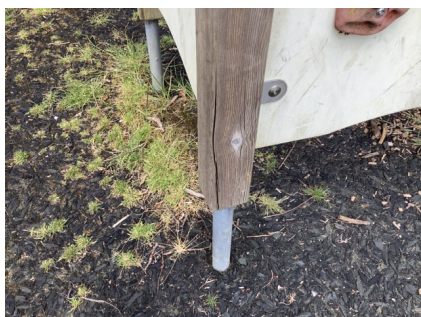
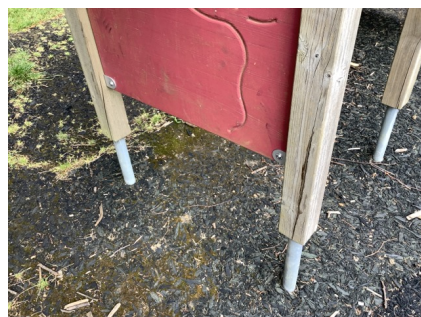
Item is cracked.

There are cracks/splits forming around base of posts. Refer to manufacturer for recommendations. This may affect structural stability of unit.

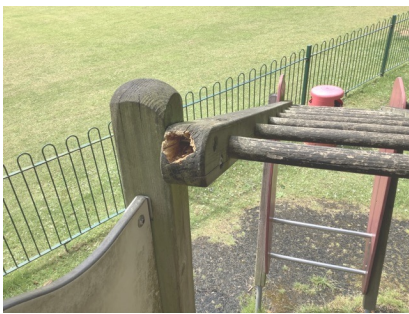
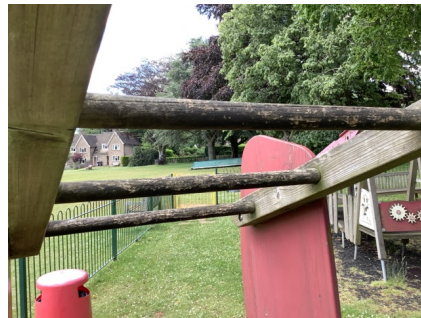
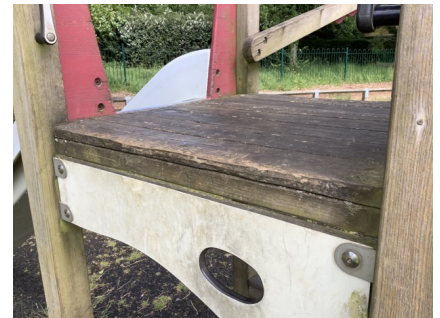
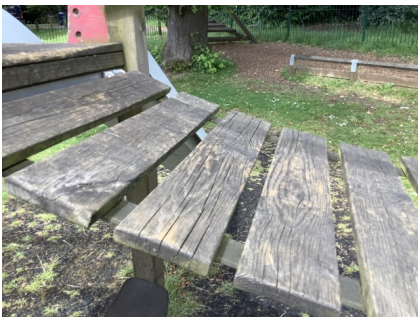
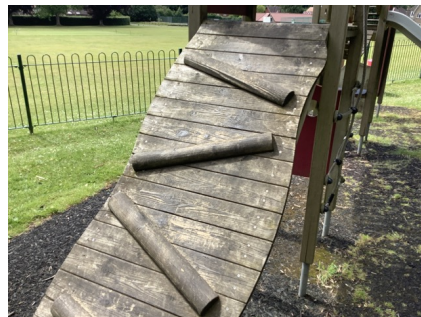
Timber is not in good condition.

Platform timbers and hand holds on overhead ladder. Monitor for further deterioration and repair or replace as needed.  
Replace overhead ladder timber top bar/s.

Check on a routine basis., Replace.
