# Safety Inspection Report

Annual Inspection

## Churt Recreation Ground

17 June 2024

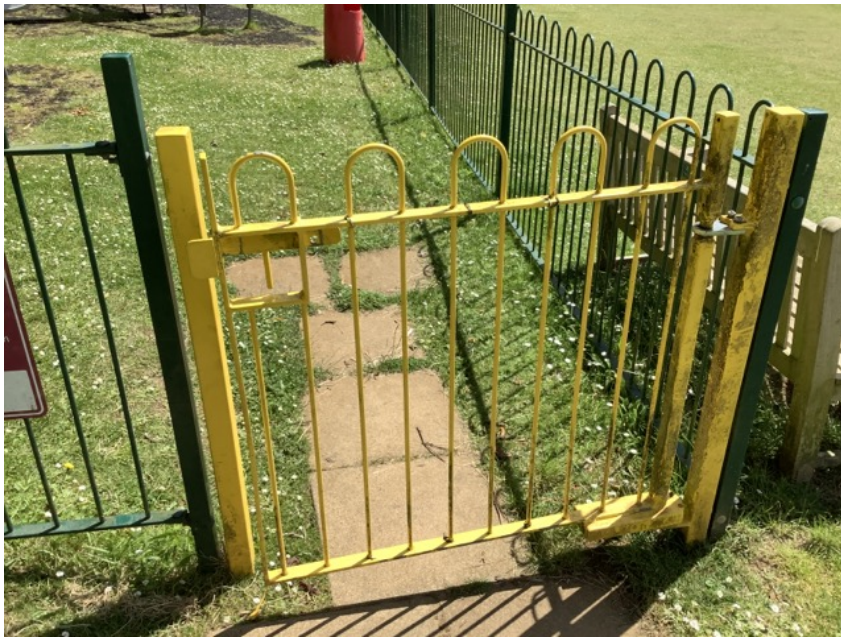
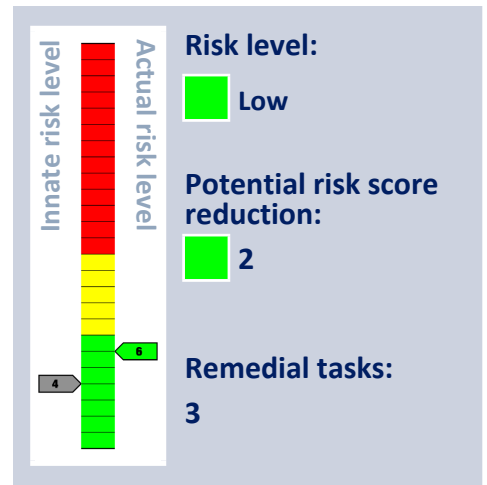
# Gates - Self-Closing x 2

Minor repairs are needed.

Trip point around entrance. Repair.  
Squeaking when in use. Lubricate.

Make level., Repair.

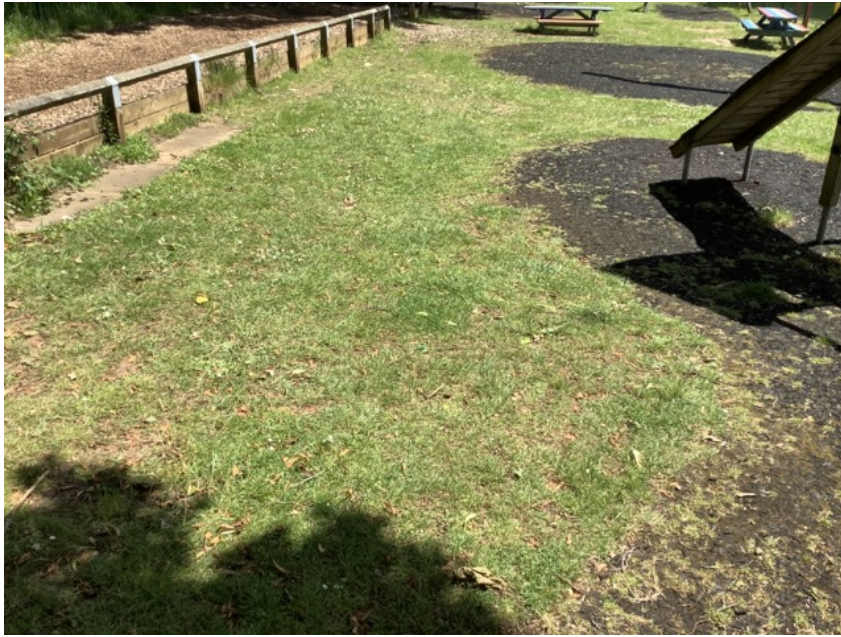
# General Surface

Bonded rubber surface is uneven in places. Monitor and repair as needed. Tree roots exposed throughout.

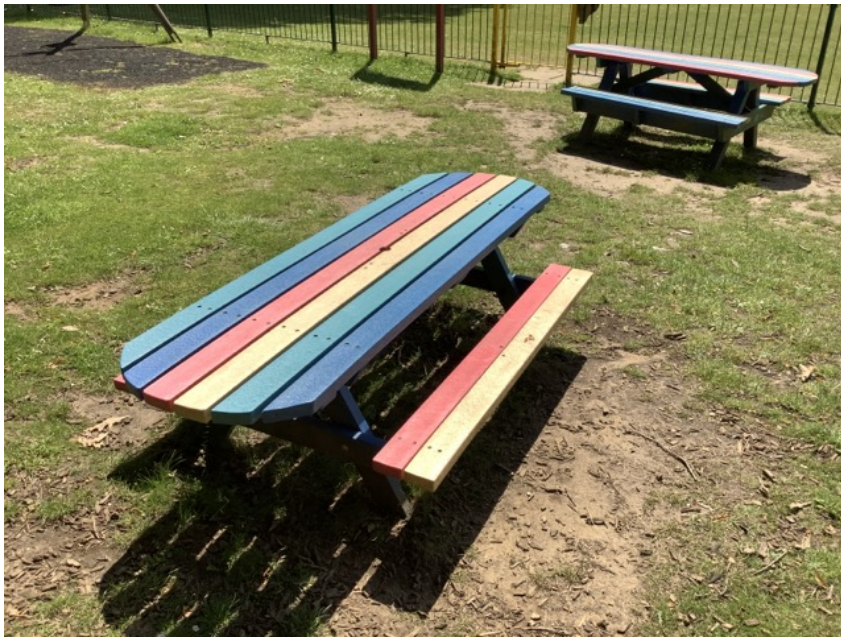
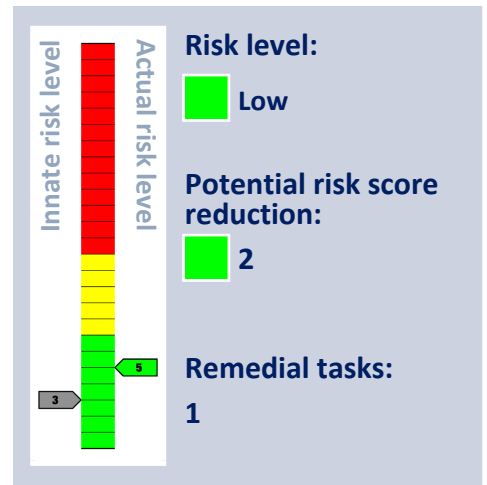
# Seating - Picnic Tables

The inspector recommends that the assets are secured in a suitable location.

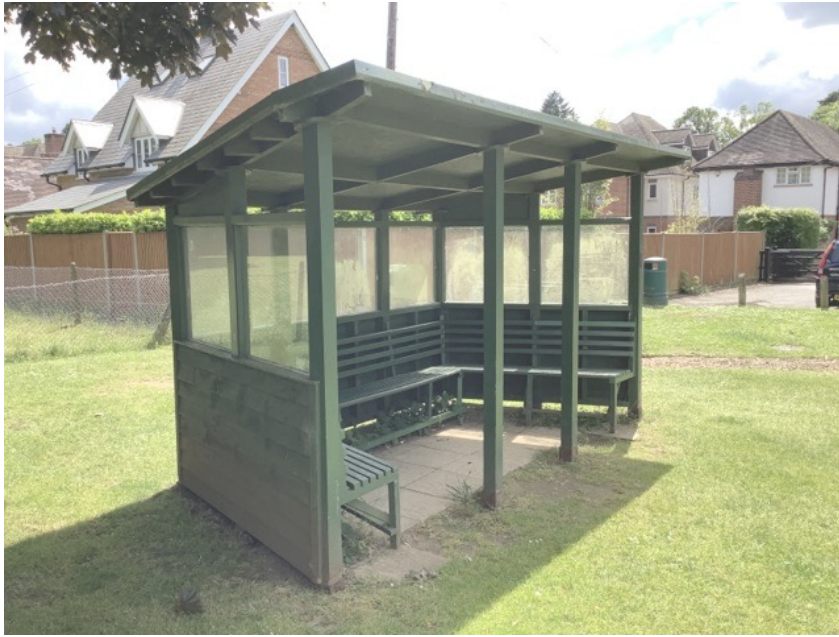
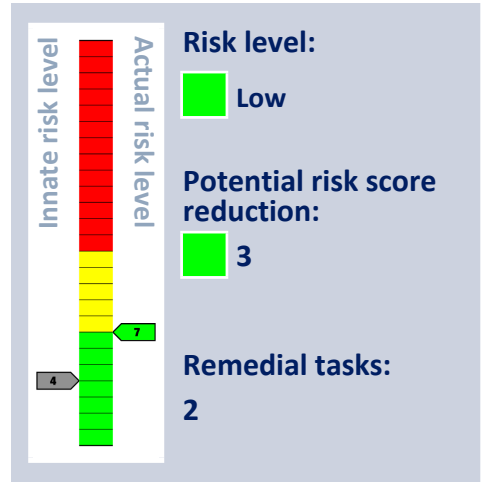
# Shelter - Youth Shelter (Field)

Moderate repairs are needed.

Decay to roof section. Replace affected parts.  
Trip points throughout. Repair.  
Remove all weeds underneath seats.

Repair., Read the notes for further action.

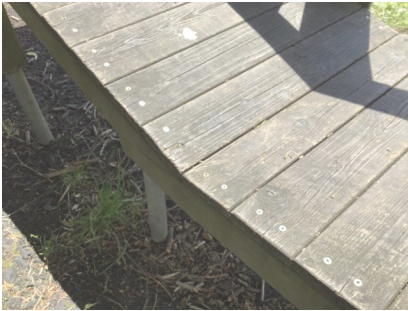
Item has some parts missing.

Missing chimes expose potential entrapments in barriers.

Replace the missing parts.

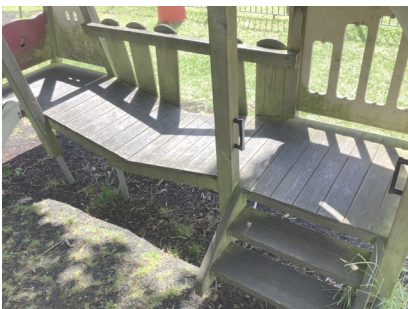
There is wear on the platform.

Repair.

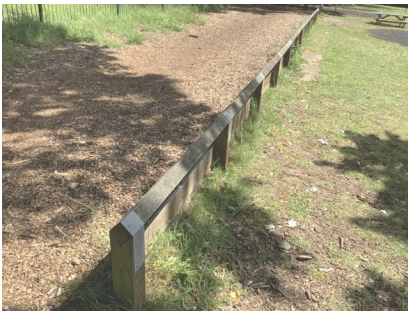
Timber is decayed.

Retaining fence posts are decayed through at ground level and loose. Replace affected parts.

Replace affected parts.

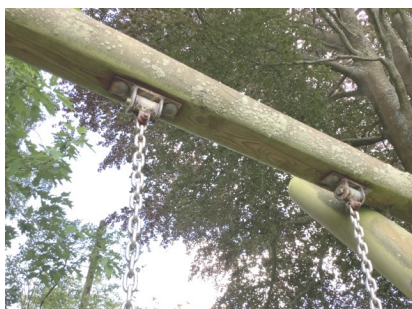
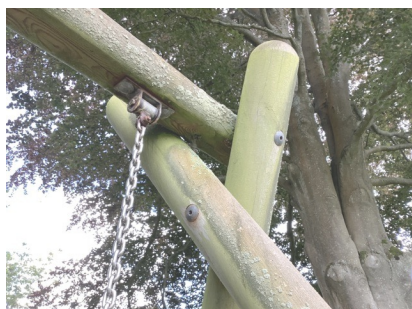
Bolt(s) loose.

Swing hangers are loose to top bar. Secure fittings.  
Top bar loose to support legs.

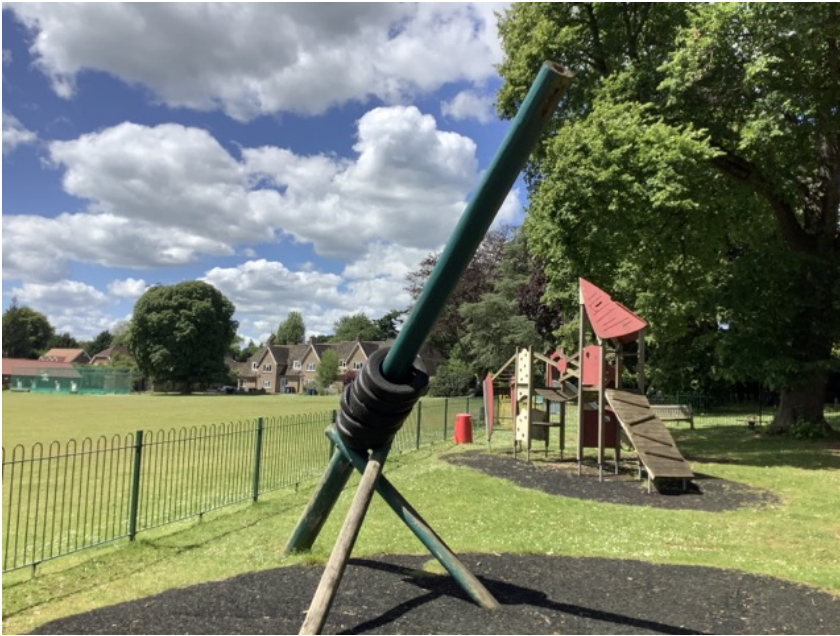
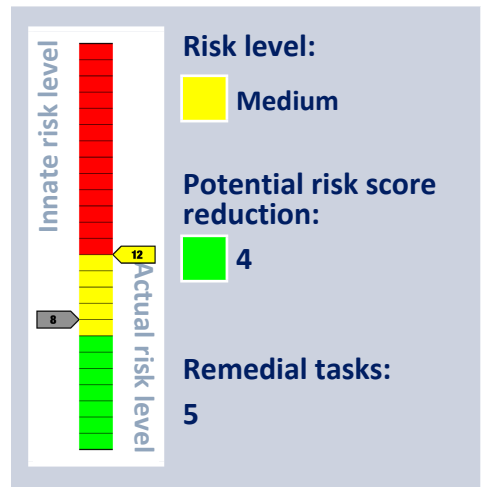
# Swing - Single Point

There is decay to timber components which may affect structural integrity. We do not recommend replacing rotten supports with timber posts which are directly set in the ground due to the increased problem of timber rot, especially in posts in contact with the ground.

Previous Percussion testing was inconclusive in areas. The timber at the top of the asset appears to be in a poor condition. Some evidence of softening within the shakes. The rate of decay appears to be quite slow. However, near fixing points. Replace.

Read the notes for further action., Replace decayed components where possible and plan replacement of item. Check on a routine basis, especially at ground or foundation level., We recommend resistance penetration testing to determine the internal condition of the timber. We can undertake this testing at additional cost. Please contact us for details.

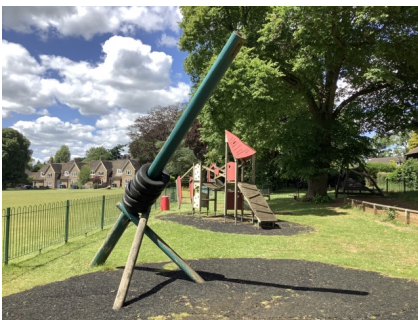
## Maintenance Finding

Swing seat(s) missing.

Replace.

Replace when available.

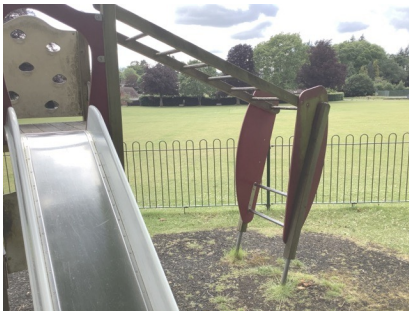
## Maintenance Finding

Minor repairs are needed.

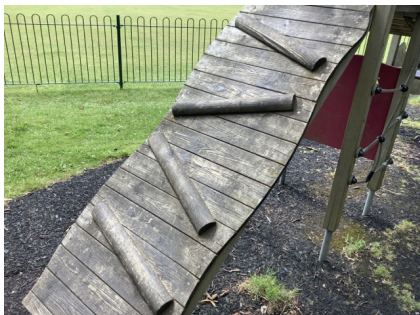
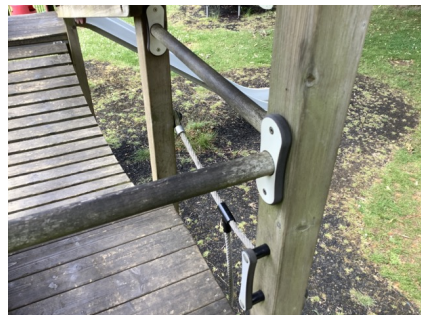
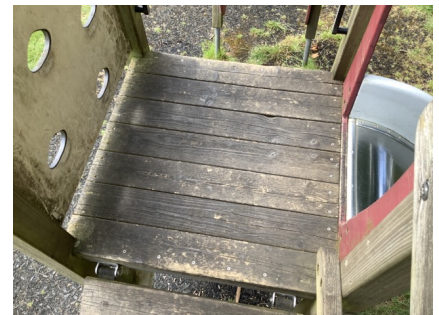
# Maintenance Finding

Timber is not in good condition.

Platform timbers and hand holds on overhead ladder. Monitor for further deterioration and repair or replace as needed.  
Replace overhead ladder timber top bar/s.

Check on a routine basis., Replace.
